WOOD DESTROYING PESTS AND ORGANISMS INSPECTION REPORT

Building No. /Street 18487 Del Bonita	City Rowland Heights	Zip 91748	Date of Inspection 04/14/2014	Number of Pages 5
<h2 style="margin: 0;">Gaston Termite & Pest Control, Inc.</h2> <p style="margin: 0;">458 W. Arrow Hwy. Suite A San Dimas, Ca. 91773</p> <p style="margin: 0;">(909) 593-1200 (800) 500-0533 Fax: (909) 593-1299</p>				
REGISTRATION No. PR 184		REPORT NO. 2057-J 5243 Escrow#		
Ordered By: Jane Wong C 21 18487 Del Bonita Rowland Heights, Ca 91748 (626) 524-2925	Property Owner and/or Party of Interest: Jane Wong C 21 (626) 524-2925	Report sent to: Jane Wong C 21 18487 Del Bonita Rowland Heights, Ca 91748 (626) 524-2925		
COMPLETE REPORT <input checked="" type="checkbox"/> LIMITED REPORT <input type="checkbox"/> SUPPLEMENTAL REPORT <input type="checkbox"/> REINSPECTION REPORT <input type="checkbox"/>				
General Description: 1 STORY, STUCCO AND FRAME, RESIDENCE, VACANT AND UNOCCUPIED, WITH A COMPOSITION ROOF, ATTACHED GARAGE, ON UNIMPROVED UNDERAREA::		Inspection Tag Posted: Other Tags Posted:

REPORT NO.2057-J 5243

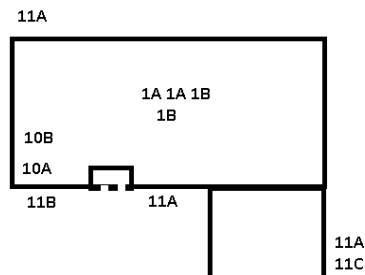
FOUNDATION DIAGRAM: (Diagram not to scale)

FINDING..... 1A. EVIDENCE OF SUBTERRANEAN TERMITES NOTED IN THE SUB AREA AS INDICATED ON THE DIAGRAM.

FINDING..... 1B. CELLULOSE DEBRIS NOTED IN THE SUBAREA AS INDICATED ON THE DIAGRAM.

FINDING..... 10A. EVIDENCE OF DRYWOOD TERMITES NOTED AT WINDOW SILL AS INDICATED ON THE DIAGRAM.

FINDING..... 10B. EVIDENCE OF DRYWOOD TERMITES NOTED AT WALL FRAMING AS INDICATED ON THE DIAGRAM.

FINDING..... 11A. EVIDENCE OF DRYWOOD TERMITES NOTED AT RAFTER TAILS AS INDICATED ON THE DIAGRAM.

FINDING..... *11B. DRY ROT NOTED AT FRONT CORBEL AS INDICATED ON THE DIAGRAM.*

FINDING..... *11C. DRY ROT NOTED AT ROOF SHEATHING AS INDICATED ON THE DIAGRAM.*

RECOMMENDATION 1A. TREAT SUBAREA SOIL WITH A REGISTERED CHEMICAL FOR THE CONTROL OF SUBTERRANEAN TERMITES.

RECOMMENDATION 1B. REMOVE CELLULOSE DEBRIS AND TAKE AWAY FROM THE PREMISES.

RECOMMENDATION 10A. DRILL AND CHEMICALLY TREAT WOOD MEMBERS WITH TIMBOR, FILL HOLES AND MINOR DAMAGE

RECOMMENDATION 10B. Foam wall void treatment, using Foam injection system; First drill quarter inch holes into void area as necessary. Then fill voids as determined using FOAM INJECTION SYSTEM to eliminate infestations. Fill drilled holes with appropriate materials. Local treatment is not intended to be an entire structure treatment method. If infestations of wood-destroying pests extend or exist beyond the area (s) of local treatment, they may not be exterminated.

RECOMMENDATION 11A. DRILL AND CHEMICALLY TREAT WOOD MEMBERS WITH TIMBOR, FILL HOLES AND MINOR DAMAGE

RECOMMENDATION 11B. CUT BACK DAMAGED CORBAL BACK AND FILL MINOR DAMAGE AS NECESSARY TO CORRECT ADVERSE CONDITION

RECOMMENDATION 11C. CUT OUT DAMAGED TIMBER AND REPLACE AS NEEDED WITH APPROVED LUMBER .
