Insured: Daniel Jaterka – 5111 Cobble Creek Dr., West Jordan, Utah.
Claim No.: 7243025939
DOL: February 26, 2010

RE: Reverse osmosis water filtration system fitting failure with caused water damage.

Preliminary Inspection Report

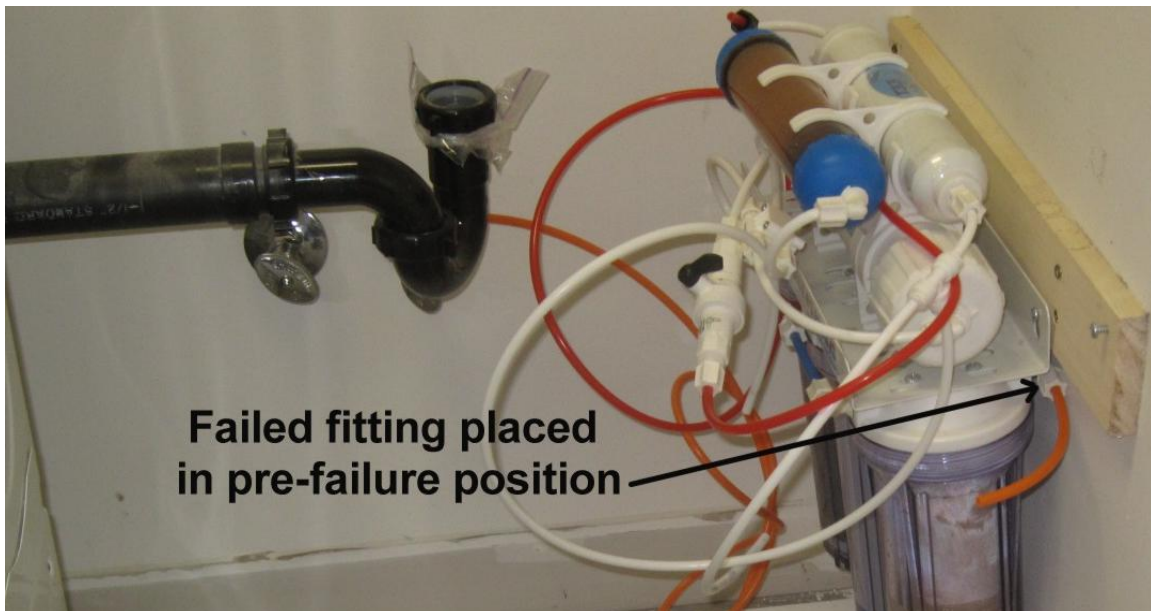
Figure 1: Reverse Osmosis filtration system in the Jaterka home.

The subject filtration system had been located in the home's finished basement, under a sink in the corner of a laundry room. It was used infrequently, to replenish a large fish tank. The filter canister and failed fitting had been situated against an interior wallboard wall (Figure 1), which would have protected the fitting from impact. The wall was not dented at the location of the fitting which indicated that the fitting had not been forced against the wall.

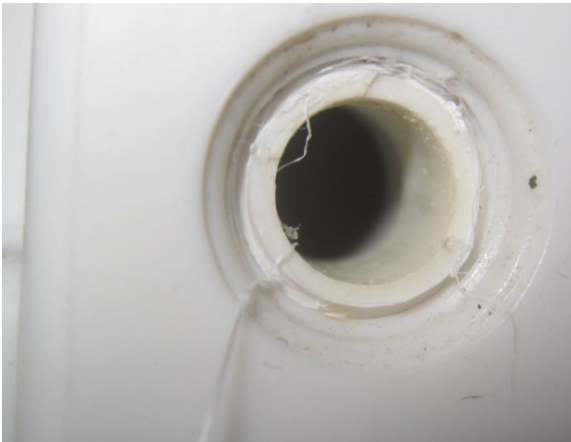
- Evidence, statements and inspection indicated that the subject fitting failed because it had been over-tightened when originally installed by the product assembler. The induced stress likely generated a crack that gradually increased in length over time until finally the fitting separated.
- The filtration system was purchased from www.PureWaterClub.com. Searching indicated that this company communicates entirely through email. Contacts listed on their website were ro-sales@purewaterclub.com and david@purewaterclub.com.

Figure 2: Fractured fitting in housing.

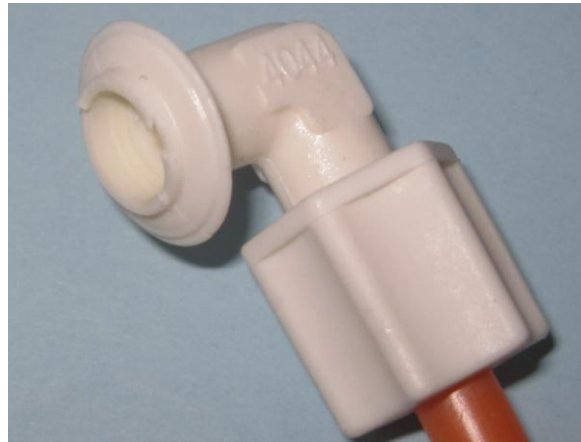
Figure 3: Opposite half of failed fitting.

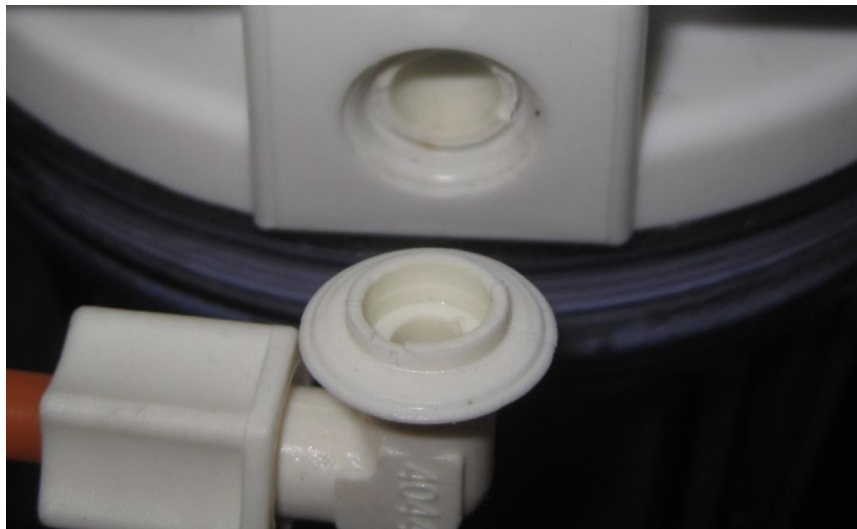
Figure 4: Failed fitting.

Microscopic inspection of the fitting's inside diameter found craze type cracking of the surface. This could be due to the stress created by over-tightening and stretching the fitting. It was considered unlikely that the crazing was caused by exposure to chemicals. The filter was attached to the West Jordan, Utah, community water supply, which should have had no effect on the fitting.

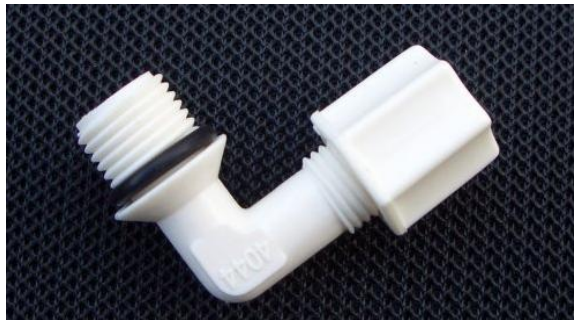
Figure 5: Replacement fitting has o-ring.

Note the apparent deformation of the flange in Figure 6 compared to the ones shown in Figures 5 and 7.

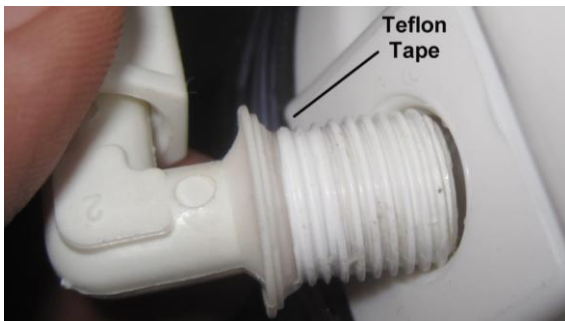
Figure 6: Adjacent fitting had no o-ring.

This suggested that the subject fitting should have had an o-ring but did not, and that it may have been taped and over-tightened in order to create a water tight joint.

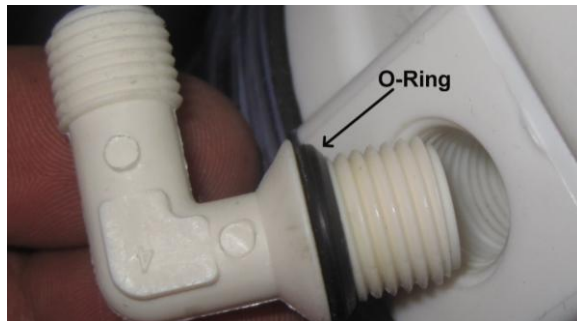
Figure 7: System fitting with o-ring.
