Property Inspection Report

17526 GLENTHRONE ST.
LA PUENTE, CA 91744

File Number 2971
Inspection Date 04/30/2012
Inspector Name HENRY FAN
Company Name VIP INSPECTION SERVICE
Address 333 W.GARVEY AVE. #54
City MONTEREY PARK State CA Zip 91754
Inspection Company Phone 866-441-3621 Fax 626-593-6598

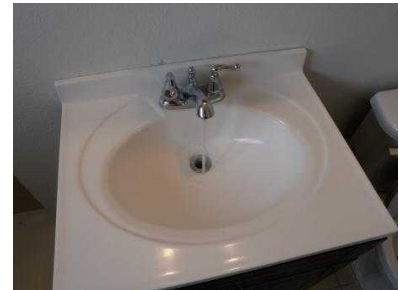
Good Ceiling:
Good Walls:
Not Rated Floor: (TILE).
Good Windows:
Good Doors:
Good Counter Top:
Good Cabinets:
Good Sink/Basin: EXCEPTIONS: MISSING STOPPER(S).

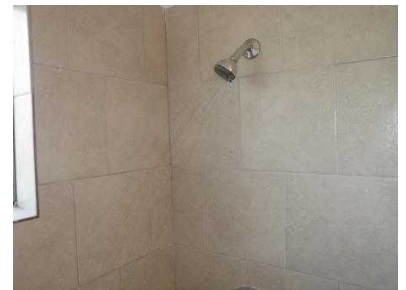
Good Mirrors:
Good-Poor Shower: NO HOT WATER FLOW, RECOMMEND FURTHER REVIEW.

1. Bathroom Shower: NO HOT WATER FLOW, RECOMMEND FURTHER REVIEW.

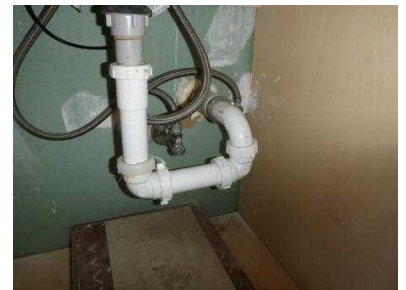
Good Shower Wall:
Good Toilets: NOTE: APPEAR TO BE LOW FLOW TYPE.
Good-Poor Plumbing: SEE SHOWER NOTE.

2. Bathroom Plumbing: SEE SHOWER NOTE.

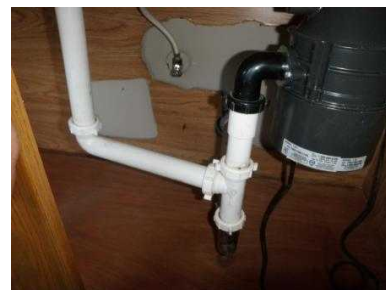
Not Rated Range: NONE.
Not Rated Oven: NONE.
Good Fan and Hood: (DUCTED).
Good Electrical: EXCEPTIONS: 2 THREE PRONG OUTLET(S) TESTED NOT GROUNDED, NTBS.
Good-Poor GFI(s): 3 OUTLETS NOT GFI PROTECTED, NTBS.

3. Kitchen Counter Tops: 1 WOOD COUNTERTOP LOOSE FROM WALL, NTBS, SAFETY CONCERN.
4. Kitchen GFI(s): 3 OUTLETS NOT GFI PROTECTED, NTBS.

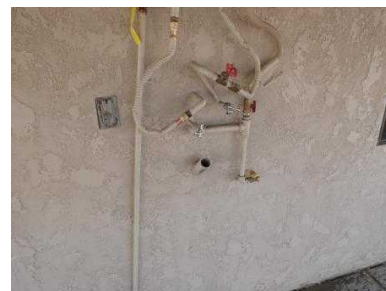
Not Rated Laundry Room Note: IN EXTERIOR.

Not Rated Laundry Plumbing: NOTE: NO LEAK OBSERVED AT THE TIME OF INSPECTION.
Not Rated Laundry Waste Line: NOTE: PRESENT, NOT TESTED.
Not Rated Dryer Gas Line: GAS LINE CAPPED.

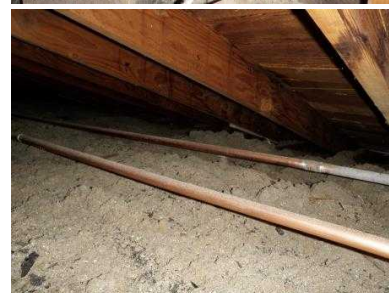
Fair Access: LIMITED INSPECTION DUE TO INSULATION, UNABLE TO VIEW ALL AREAS.
Good Access Cover:

1. Attic Access: LIMITED INSPECTION DUE TO INSULATION, UNABLE TO VIEW ALL AREAS.

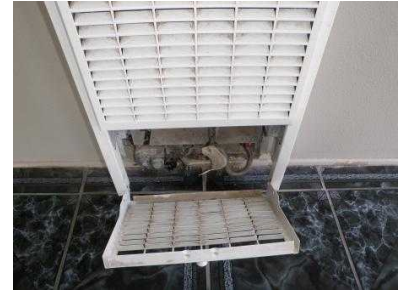
Not Rated Heating System Note: IN LIVING ROOM.

Not Rated Heating Type: GAS, WALL FURNACE.

Not Rated Temp Range: STARTING TEMP: 75; OPERATING TEMP: 158.

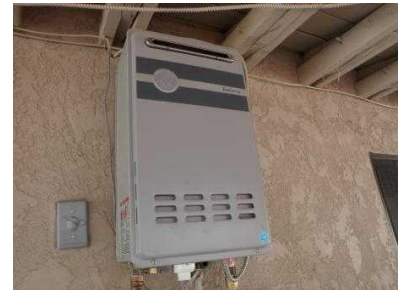
Not Rated Water Heater Note: AT EXTERIOR.

Not Rated Type-Mfgr-Year: GAS, (RHEEM, 2008).

Not Rated Gallons: TANKLESS.

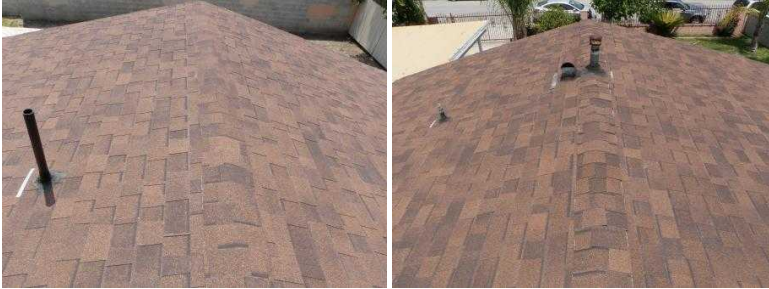
Not Rated Type: GABLE.

Not Rated Material(s): COMPOSITION SHINGLE.

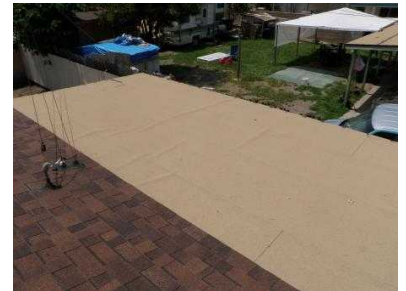
Patio Roof - Cover: (ROLL COMPOSITION). EXCEPTIONS: UNEVEN IN AREAS.

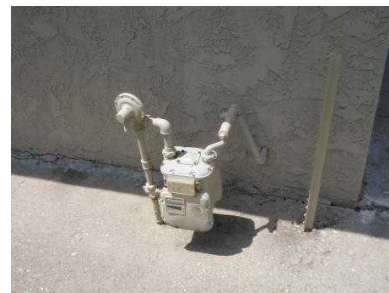
- Good Exterior Plumbing:
- Not Rated Main Water Valve: (NORTH SIDE). NOTE: VALVE IS NOT TURNED BY INSPECTOR.
- Good Main Water Pressure: 50 PSI, WITHIN NORMAL RANGE OF 50 - 90 PSI. NOTE: NO PRESSURE REGULATOR VISIBLE.
- Not Rated Supply Lines: (COPPER, WHERE VISIBLE).
- Not Rated Waste Lines: NOTE: NOT INSPECTED.
- Not Rated Main Gas Valve:

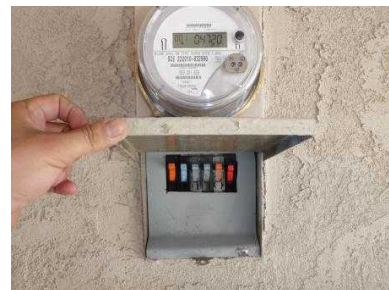
- Not Rated Entrance Wires: (OVERHEAD).
- Not Rated Amps-Volts: UNKNOWN AMPERAGE. APPEARS UPGRADE IS NEEDED TO OPERATE MODERN APPLIANCES.
- Good Main Panel:

- Not Rated Panel Wiring: SECURED, UNABLE TO INSPECT.
- Good Breakers:
- Not Rated Ground-Bound: UNABLE TO VIEW.
- Good Exterior Electrical:
